| **Subject:** | RE: UPDATE RE: Disappointment with Flock.... also possible camera adjustment Cam "030 SB Broadway (South of Carmen-Lane 2 and 3) |
| **Date:** | Thursday, January 4, 2024 7:35:39 AM |

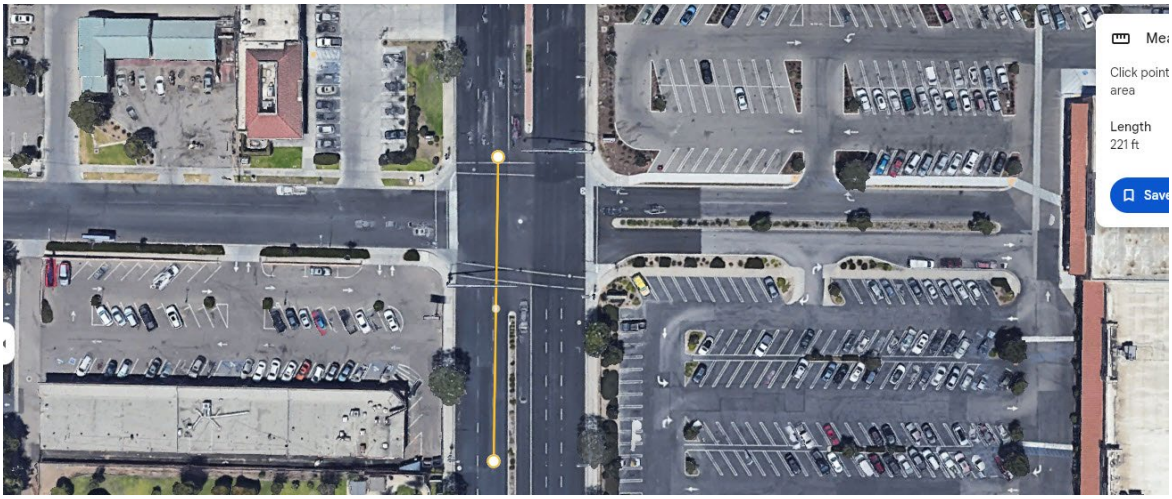
> Flock Safety Support,
>
> I’m writing to express disappointment with the performance of your cameras on a recent case.
>
> A semi tractor pulling a tanker trailer entered our city and stole 6,000 gallons of fuel and left without being recorded by any of our 166 Flock cameras.
>
> Video shows it traveling s/b on Broadway from the 1800 block on 12/24 at 06:54:01 Hrs.

Flock Camera “030-SB Broadway (south of Carmen-Lane 2 and 3) is less than 200 feet away and the truck definitely passes the camera as there is no place to turn prior to the camera.

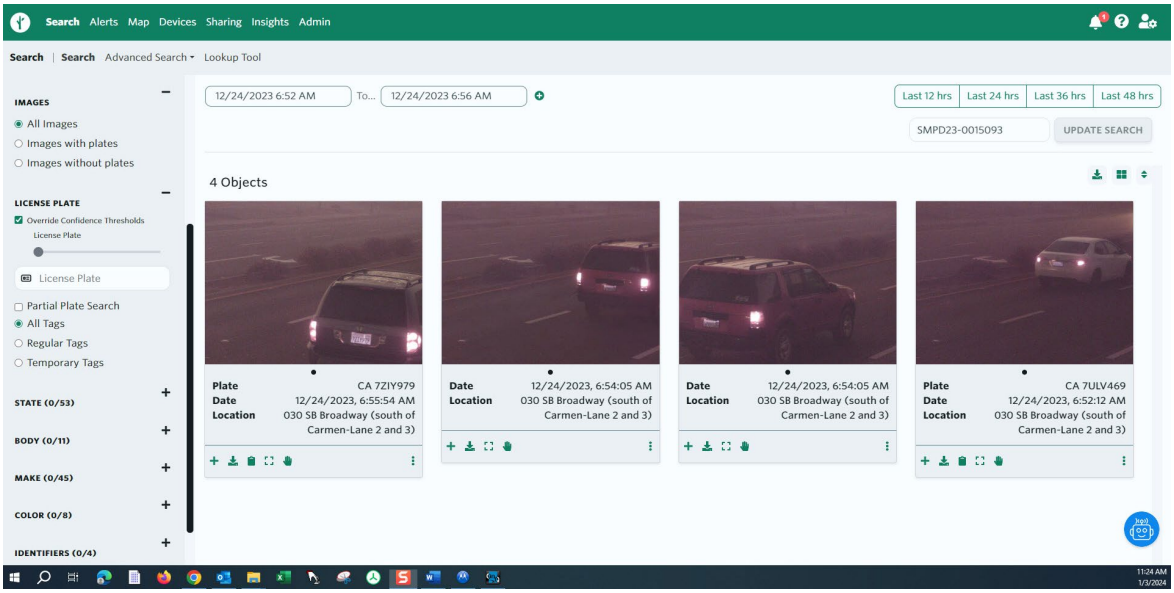
A search of All Images from this camera for 0652-0656 Hrs. does not show the semi and trailer at all.

However, about 40 minutes later, the camera does get a partial photo of an un-related semi and tanker trailer but misses the plate.

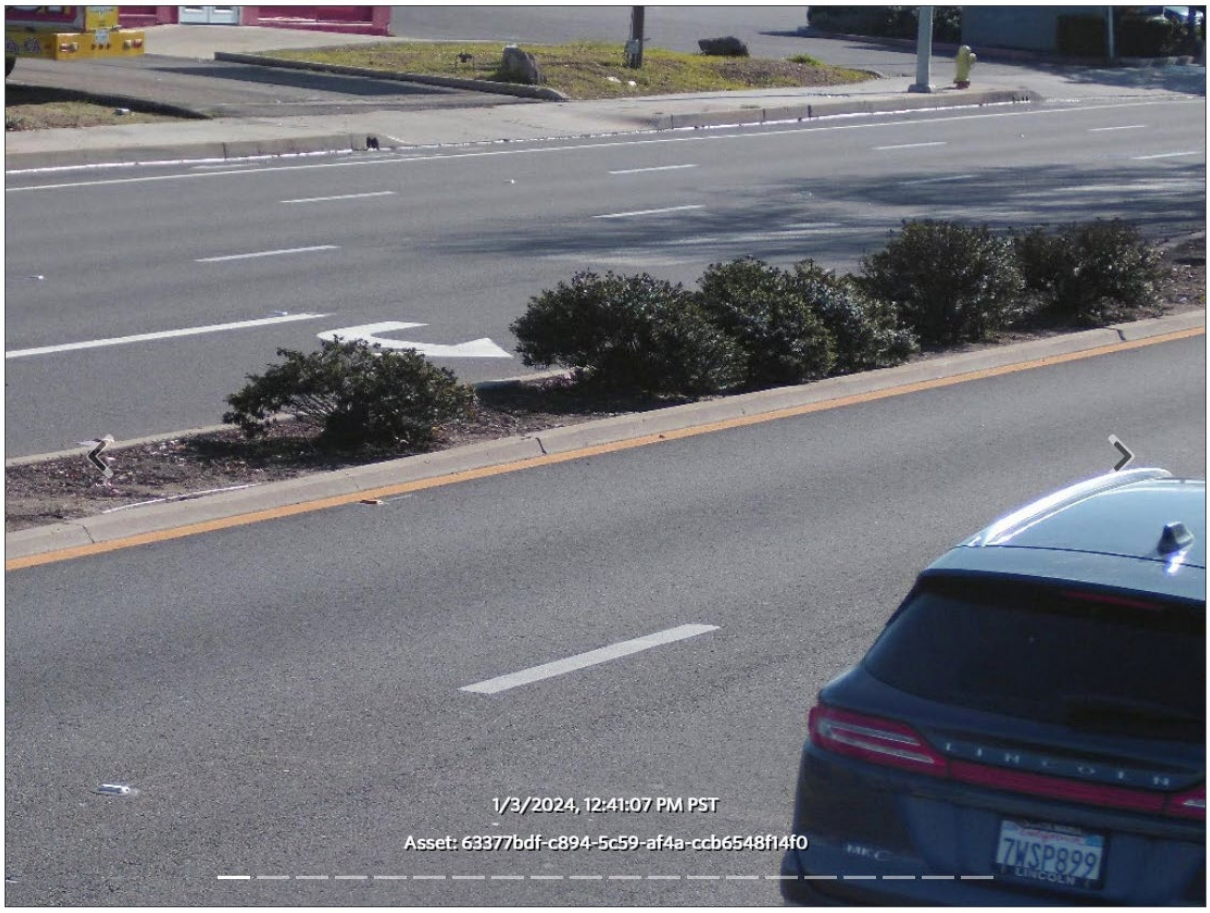
Hi Corporal Best,
Adam here. I'm very sorry to hear about this miss. It appears to be too tight of an angle to capture a vehicle as long as this fully, if at all in this case. Angling the camera further to the right could presumably allow the vehicles to be in frame longer, but of course that would also alter the way the results appear for other vehicles. Happy to give it a shot if you'd like, just let me know.

As far as Adjustments.  Camera “030 SB Broadway (south of Carmen-Lane 2 and 3) clearly is pointing more at Lane 1 and 2.  (which I think is ok, so I may re-name the camera)

Do you think moving the angle more to the right might get better coverage of Lane 1 and 2 and possibly a bit of lane 3 and not so much of the n/b lanes?

Also, can the timing be changed on the camera so it can get multiple images of each passing vehicle and maybe get the side and rear of semi trucks?
